PRE SALE EVALUATION

THIS IS NOT A FULL INSPECTION
Prepared Exclusively for
May Beselling

Prepared by: Your Inspector on February 21, 2007

RE: 411 Needtoknow Road
Anytown, USA 00411

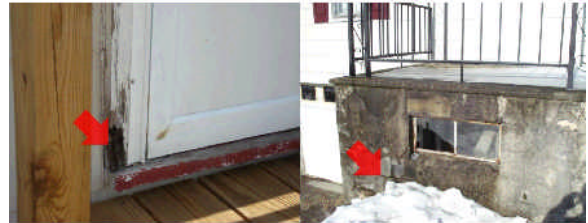
Front porch foundation cracks and settlement noted. Door frame rot noted.

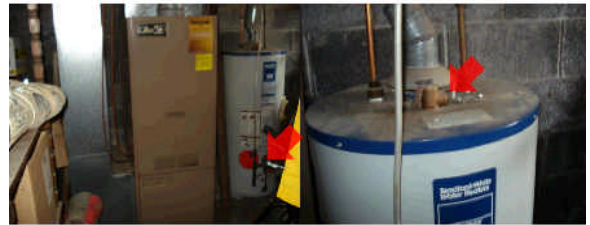
LP gas fired hot water heater noted in the basement. Proper ventilation should be present to prevent pooling in the event of a gas leak. Pooling gas can be ignited by pilot lights. Install pressure relief valve extension. "Potential ReD Flag"
